**US Army Corps
of Engineers®**
Engineer Research and
Development Center

Geomorphic Analysis of Mattituck Inlet and Goldsmith Inlet, Long Island, New York

Michael J. Morgan, Nicholas C. Kraus,
and Jodi M. McDonald

July 2005

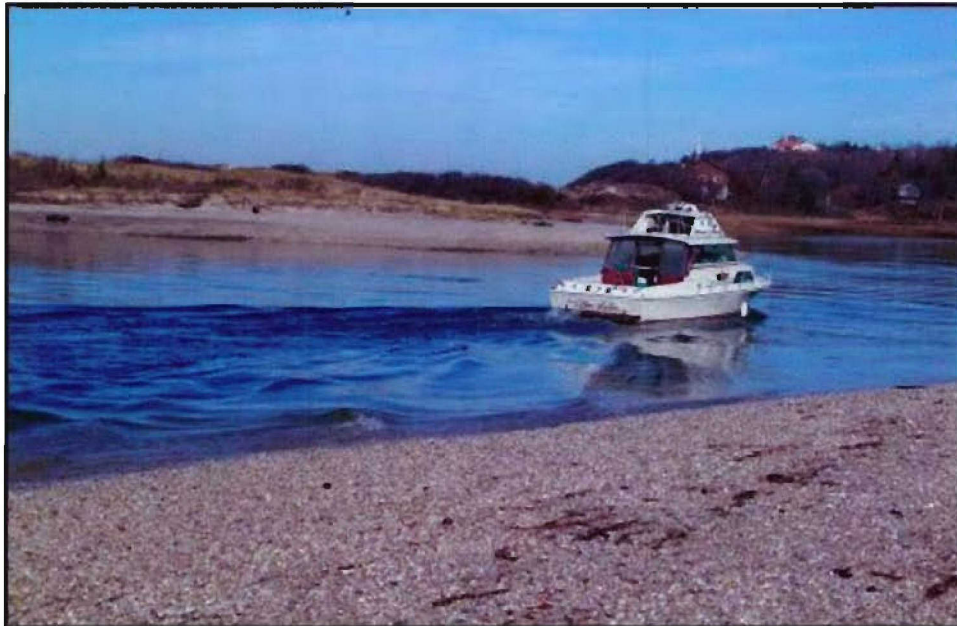
Figure 2-10. Mattituck Inlet channel, after turn eastward inside jetties. Large deposits of gravel and sand line both sides of channel, 21 November 2003

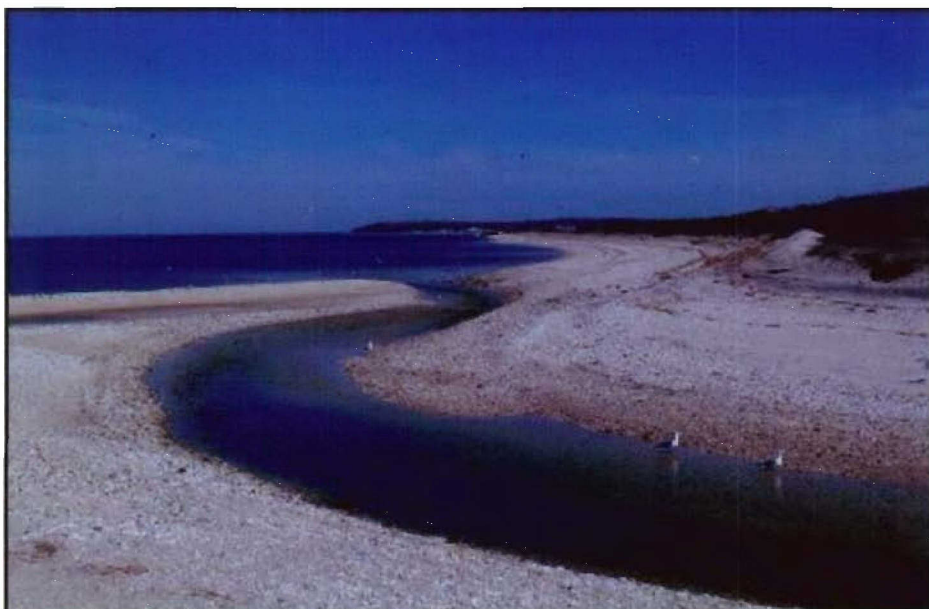
Figure 2-27. Goldsmith Inlet entrance with view of east beach, 28 March 2003

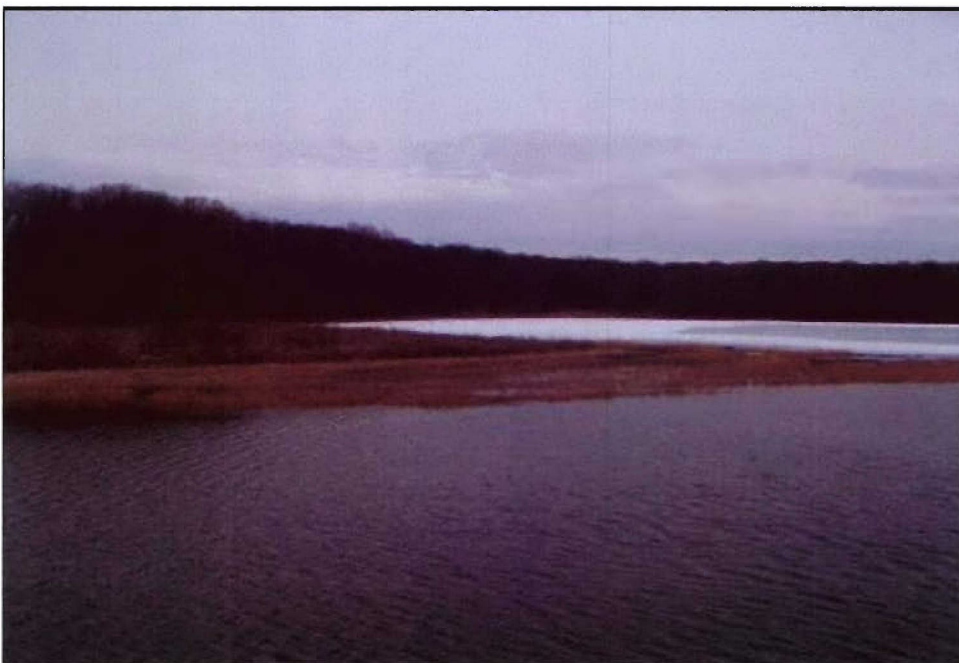
Figure 4-51. Goldsmith Inlet, east bank wetland, 20 February 2004
